First Permitted Use of Alum in the State

*Learning from the Past to Protect
the Future at Big Elk Meadows*

Steve Lundt
Sustaining Watershed Conference
Vail, Colorado
October 5-7, 2010

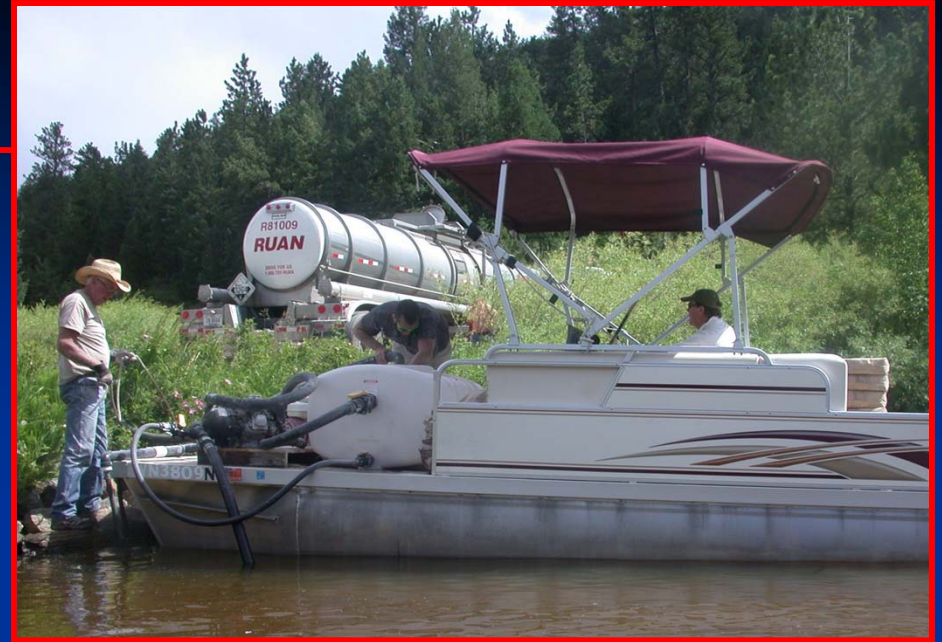
Monitoring:

Pre (Sediments & Water)

During (pH, Nutrients)

Post (Sediments & Water)

Long-term Monitoring
