Implementation of Stream Restorations on Tribal Lands through the Clean Water Act Section 319

Beaver Creek Stream Restoration

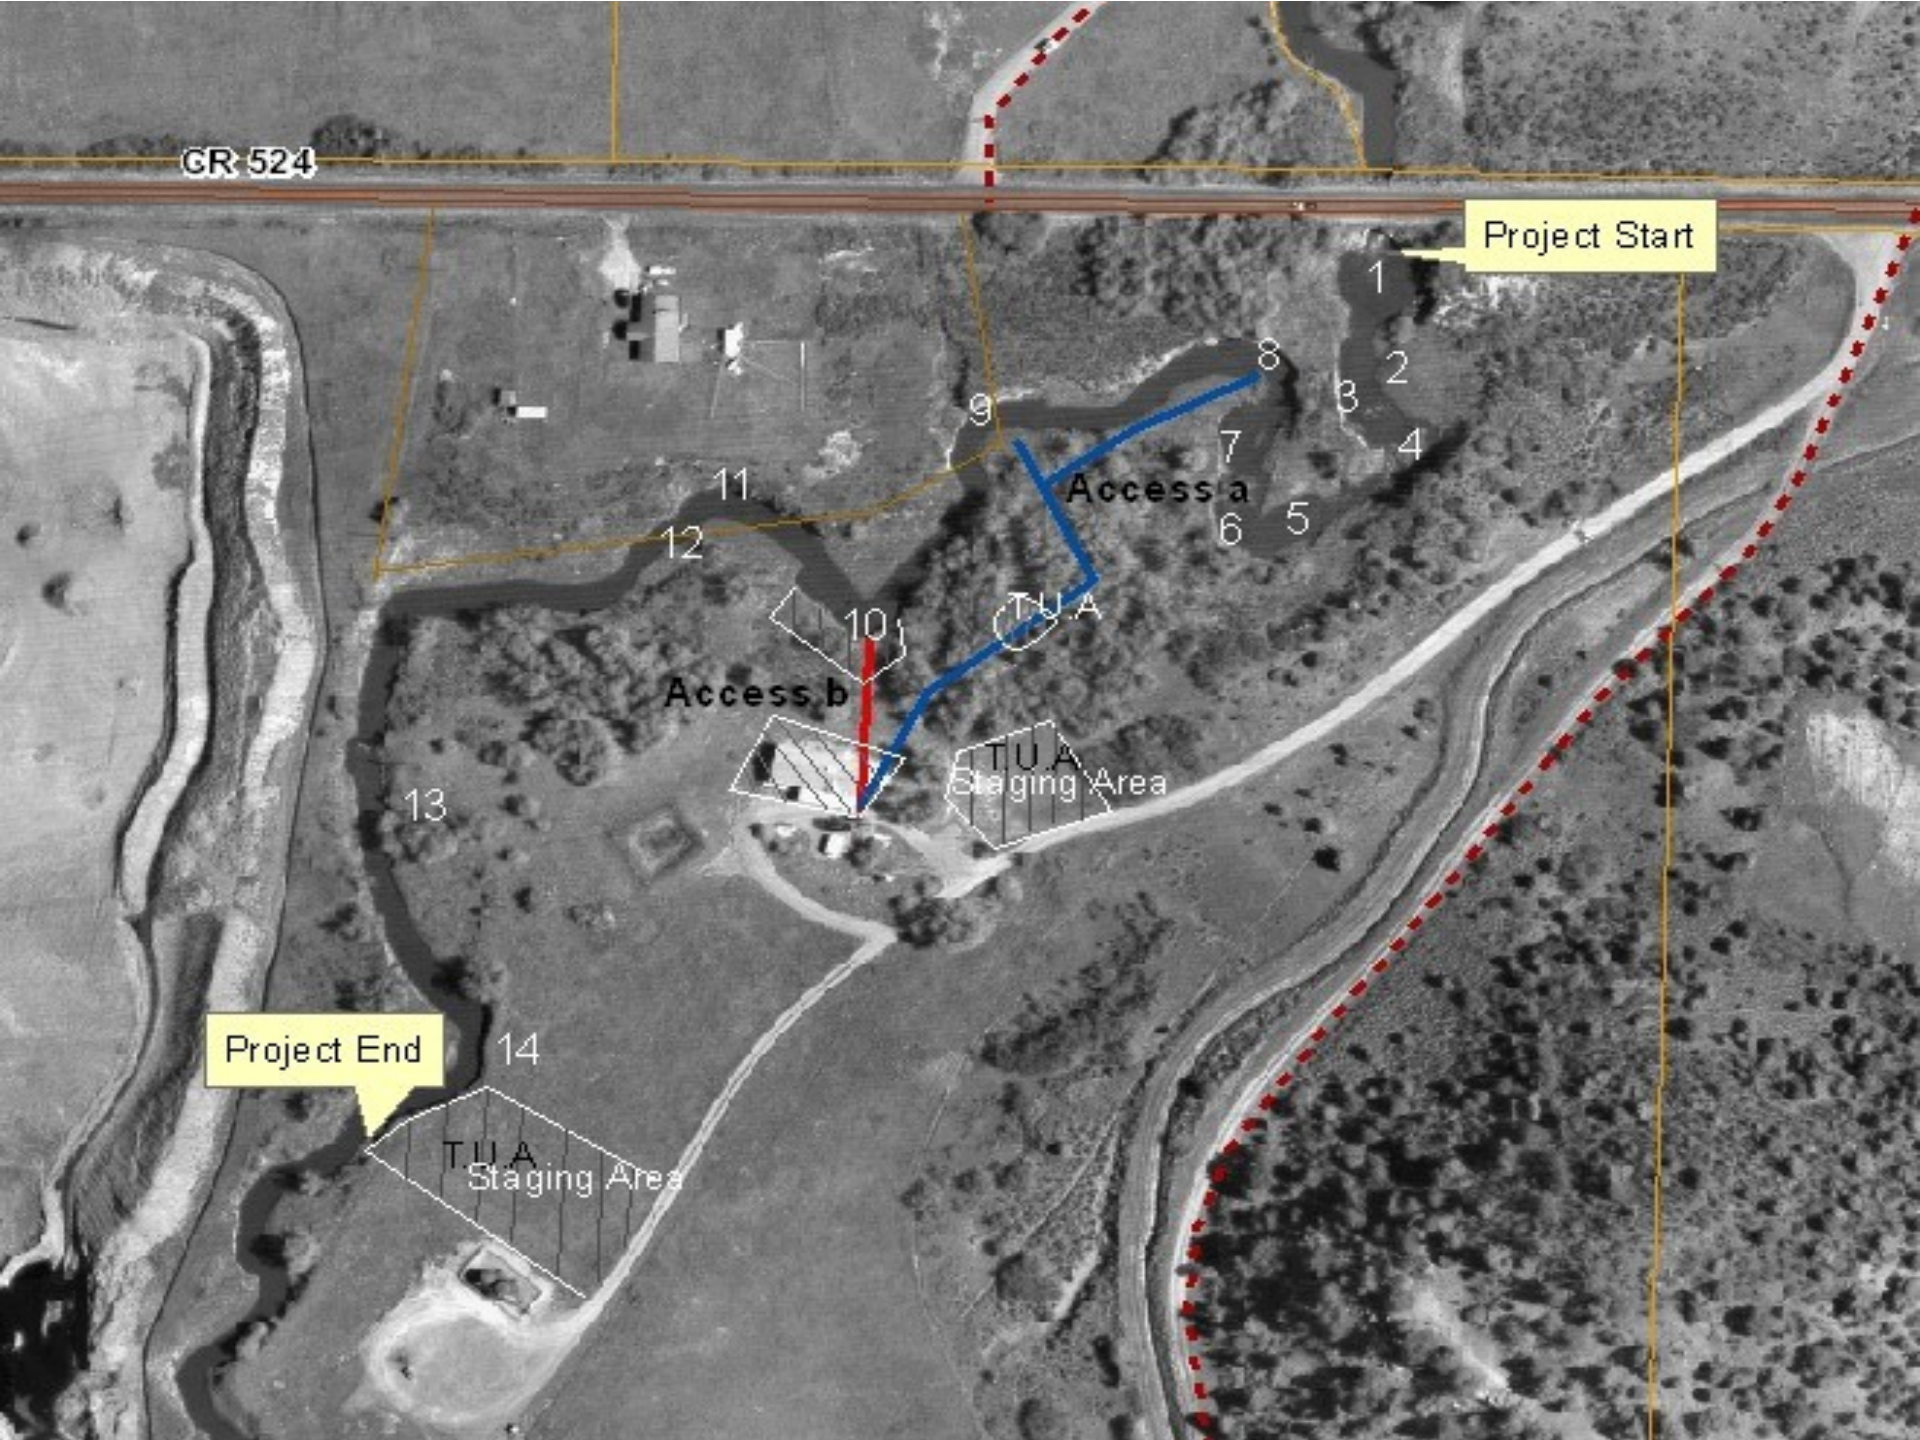
- Identify Banks that need to be stabilized.
- Identify access routes, staging areas, etc.

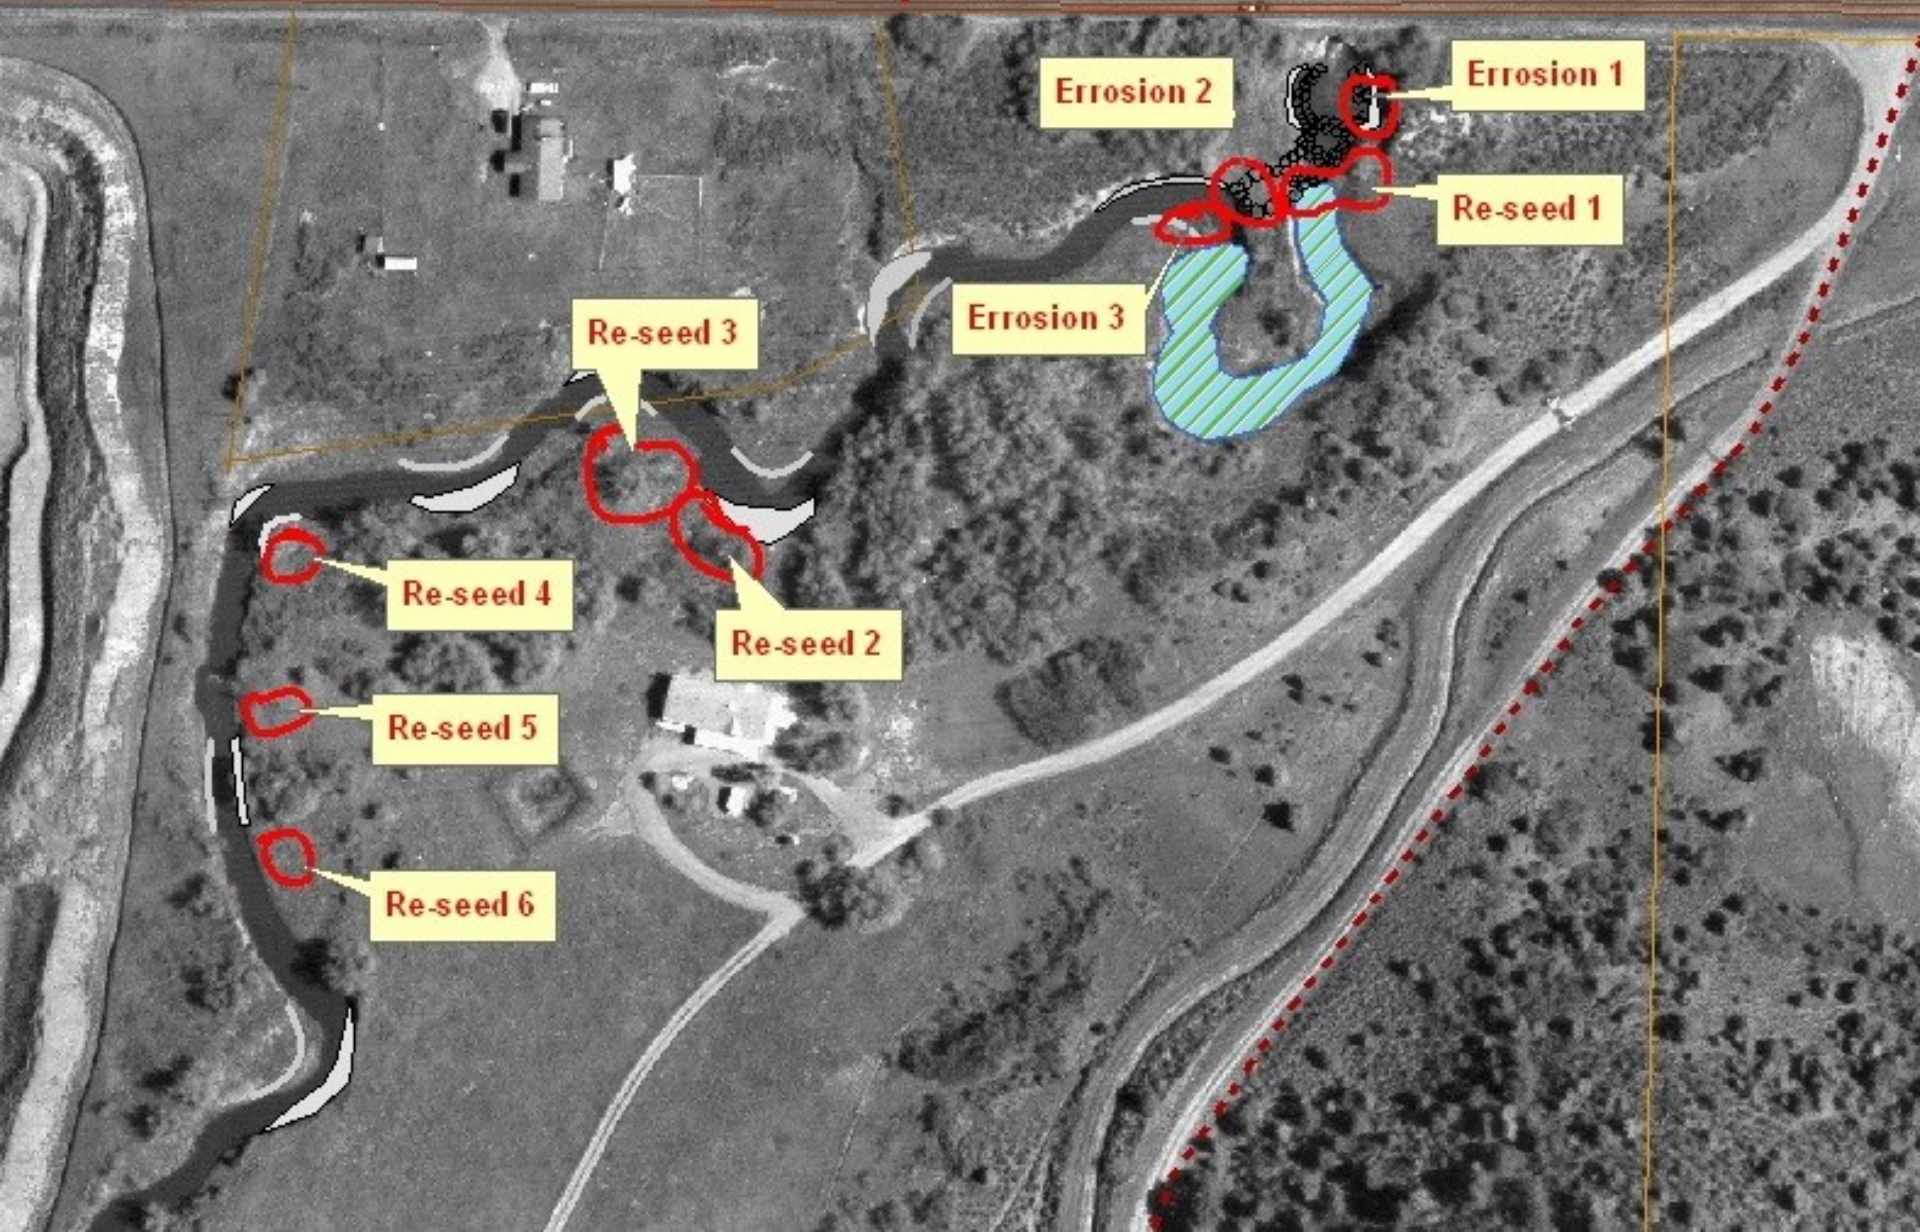
Areas of concern

Erosion 2

Erosion 1

Re-seed 1

Erosion 3

Re-seed 3

Re-seed 4

Re-seed 2

Re-seed 5

Re-seed 6

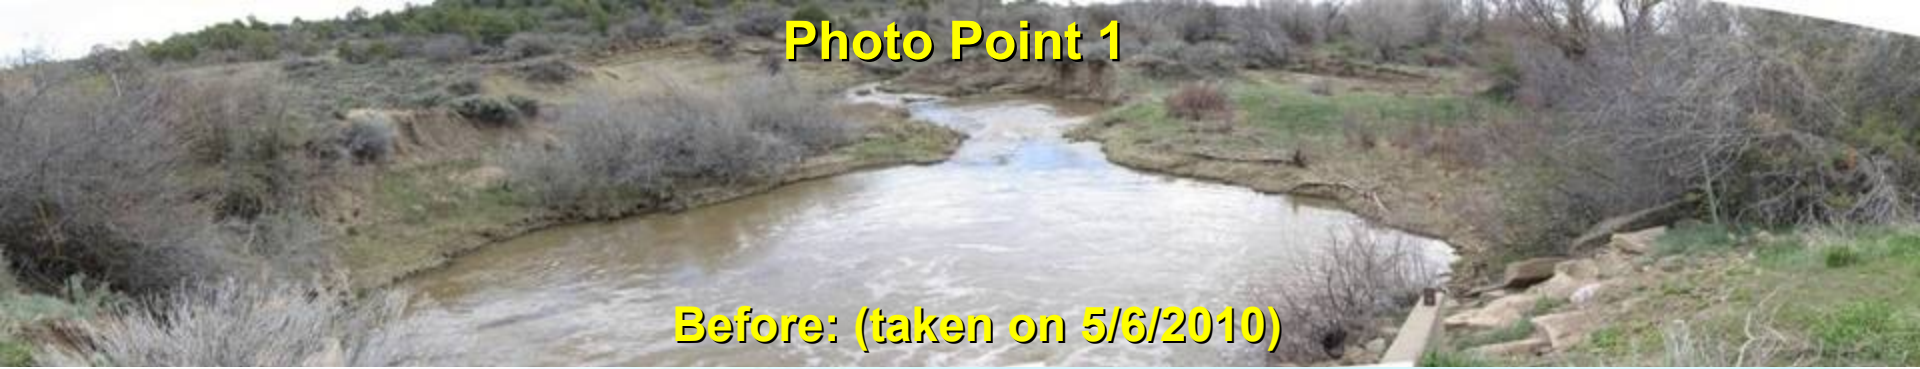
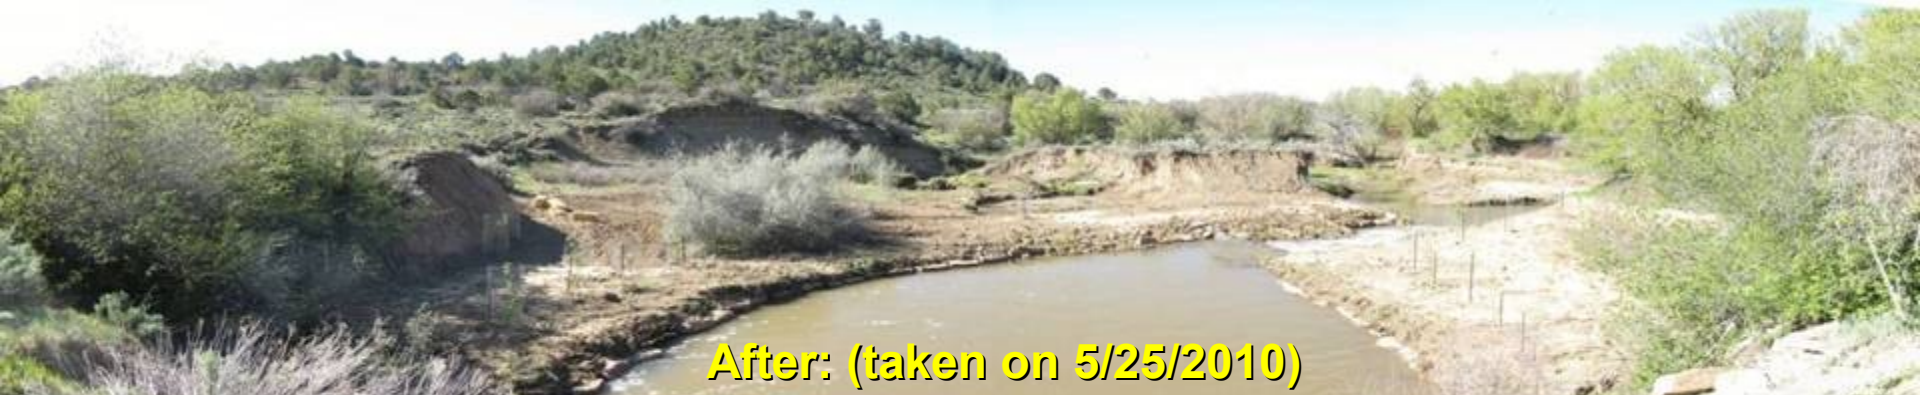
Photo Point 1

Before: (taken on 5/6/2010)

After: (taken on 5/25/2010)

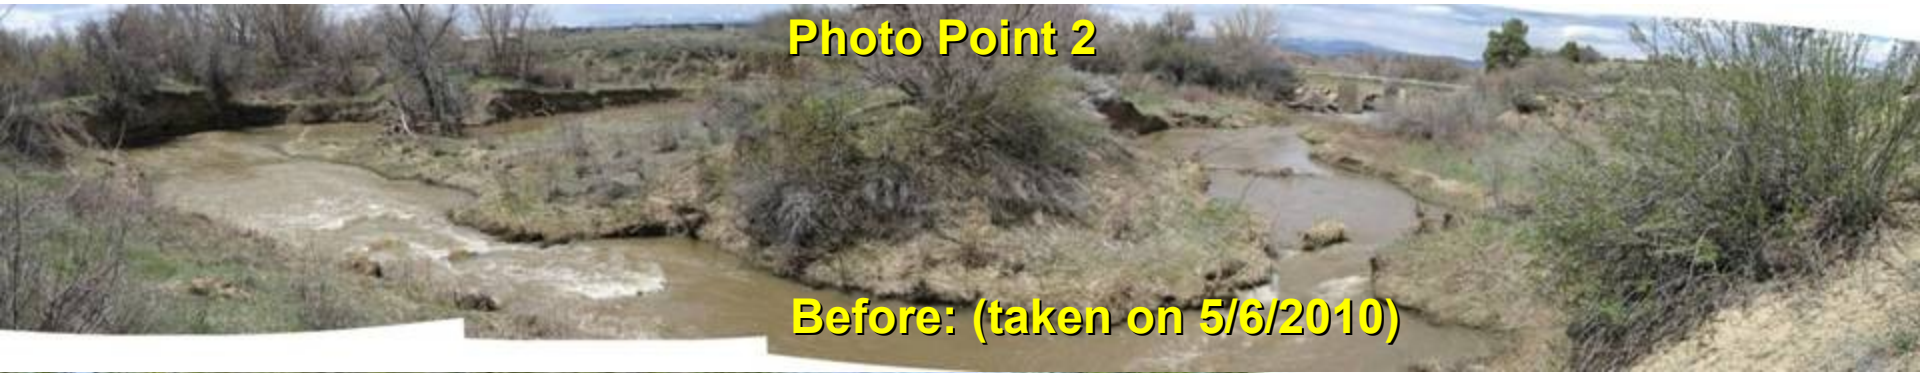
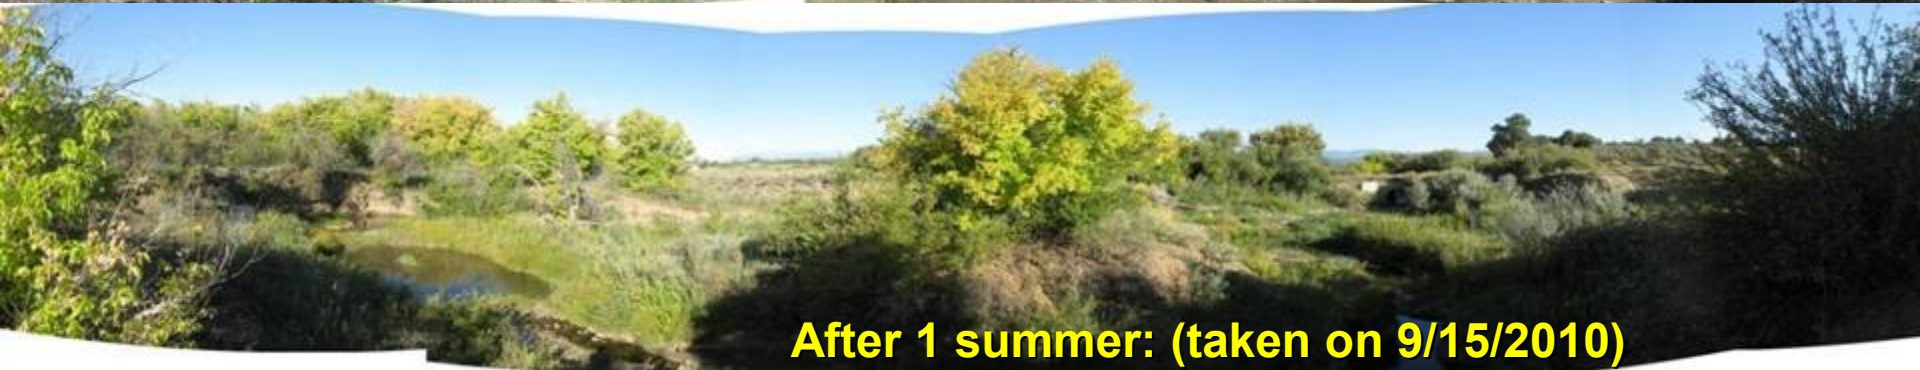
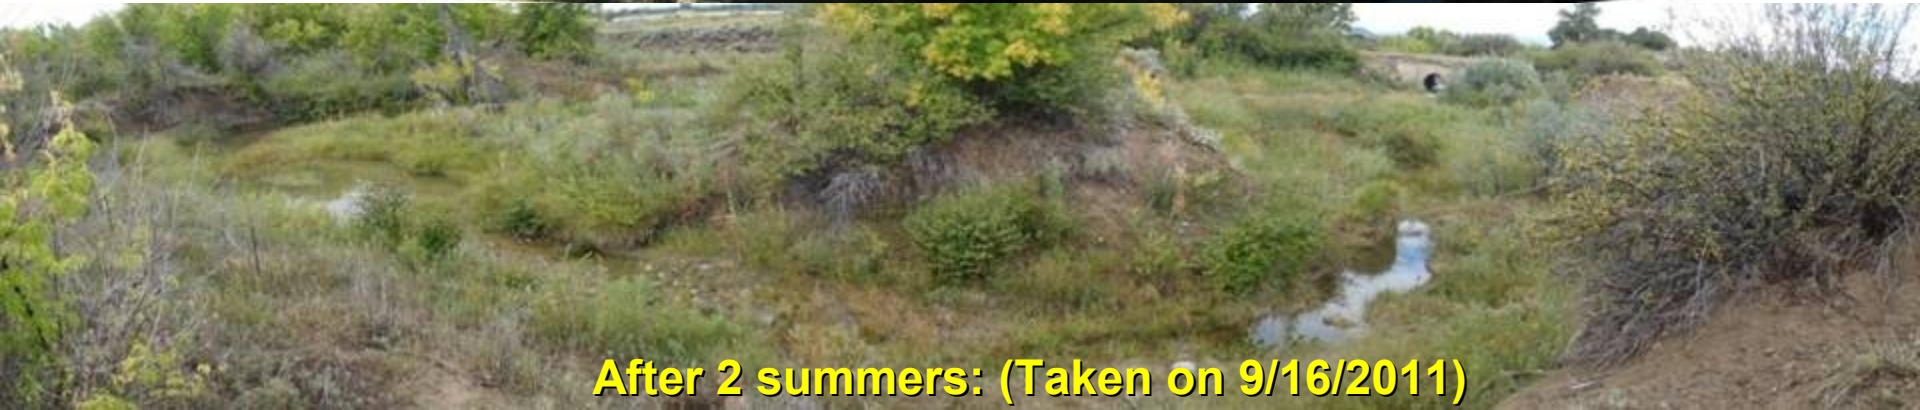
Photo Point 2

Before: (taken on 5/6/2010)

After: (taken on 5/25/2010)

After 1 summer: (taken on 9/15/2010)

After 2 summers: (Taken on 9/16/2011)

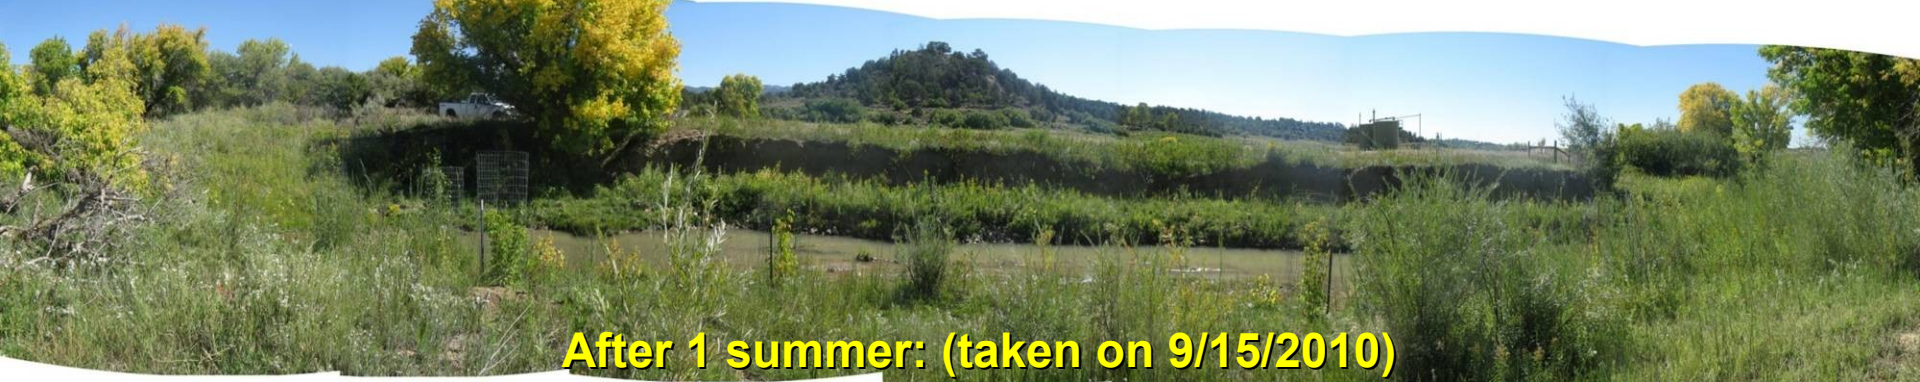
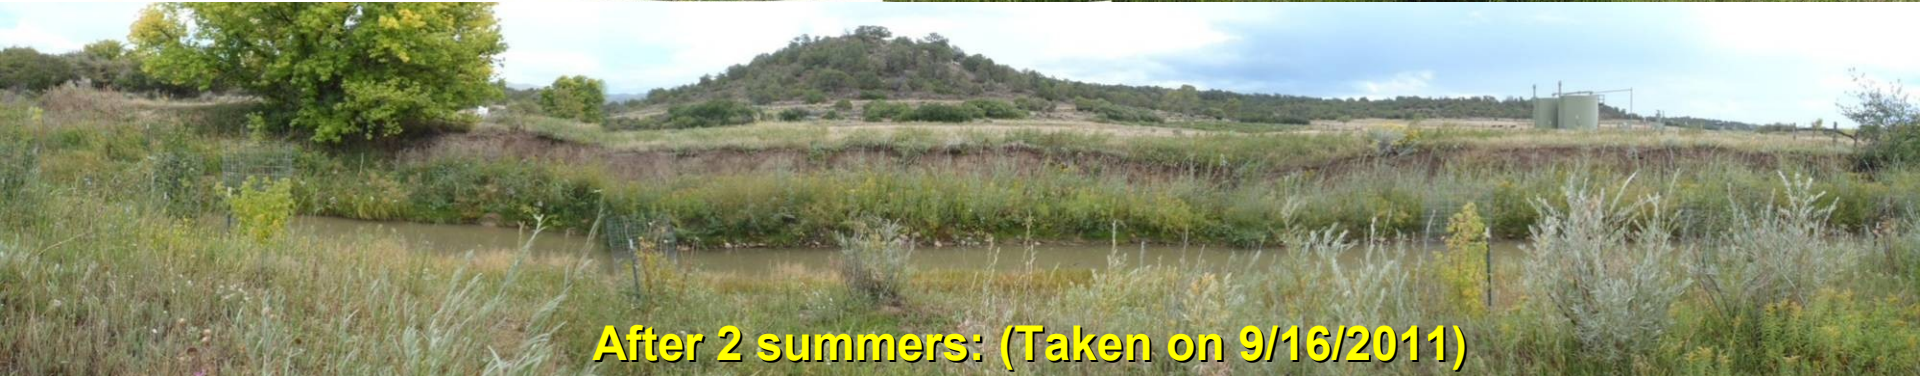
Photo Point 9

After: (taken on 5/25/2010)

After 1 summer: (taken on 9/15/2010)

After 2 summers: (Taken on 9/16/2011)

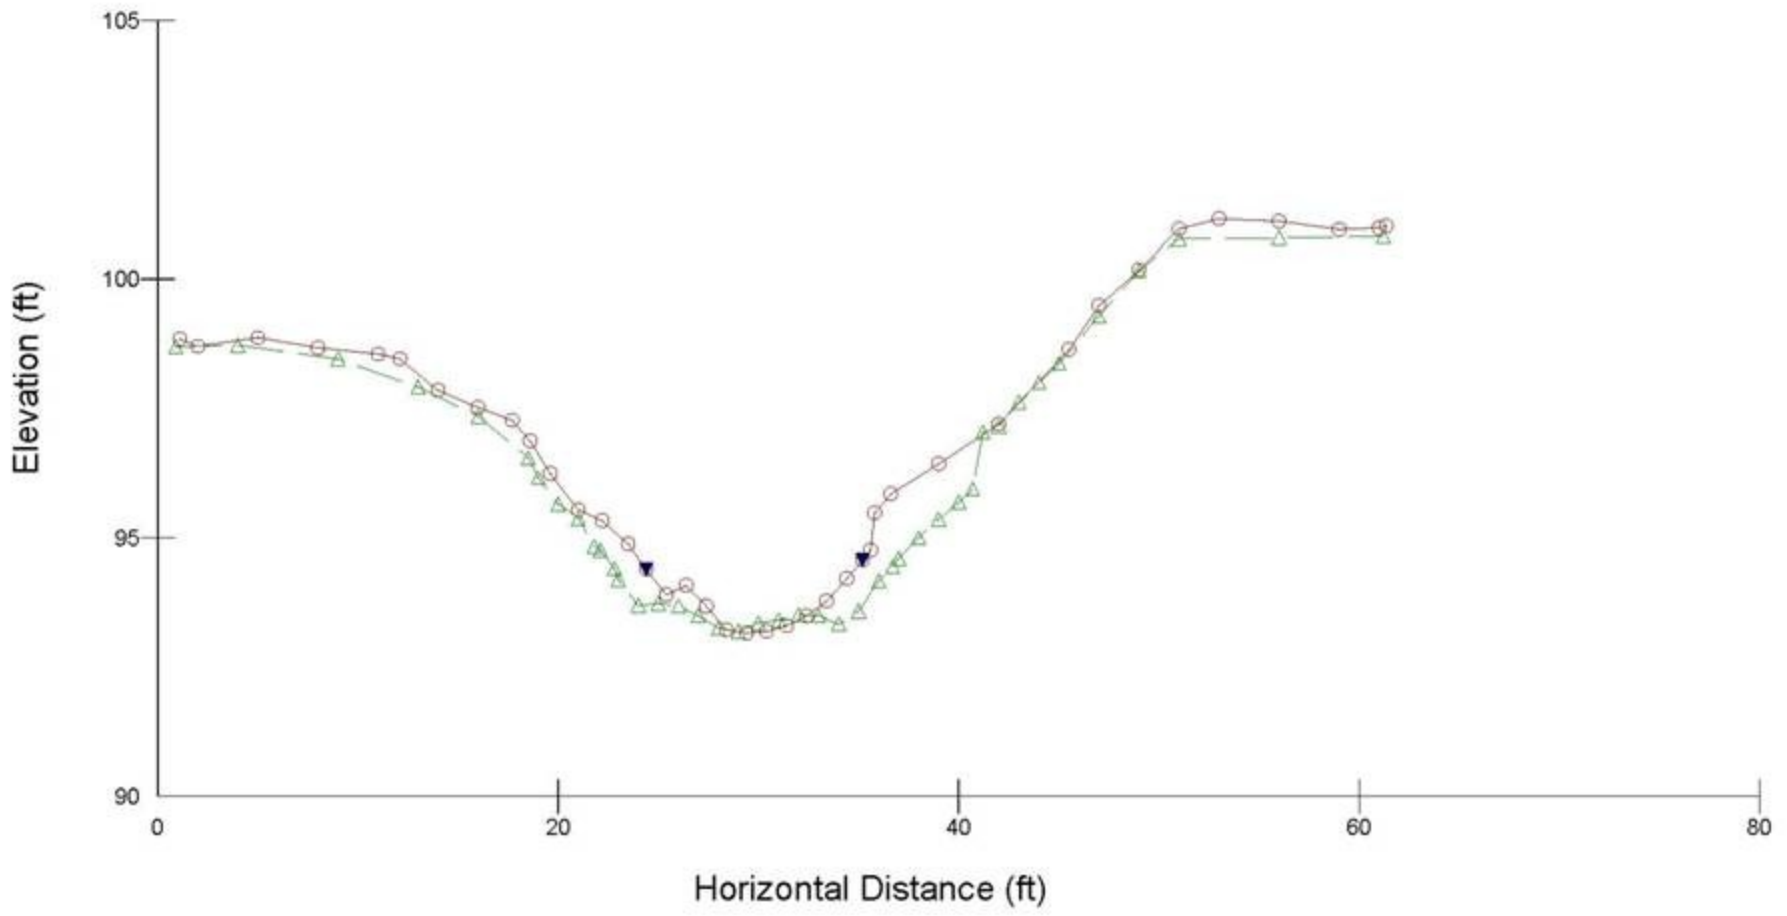
○ Cross Section 1 7/26/2010 ◆ Bankfull Indicators ▼ Water Surface Points △ Cross Section 1 9/19/2011

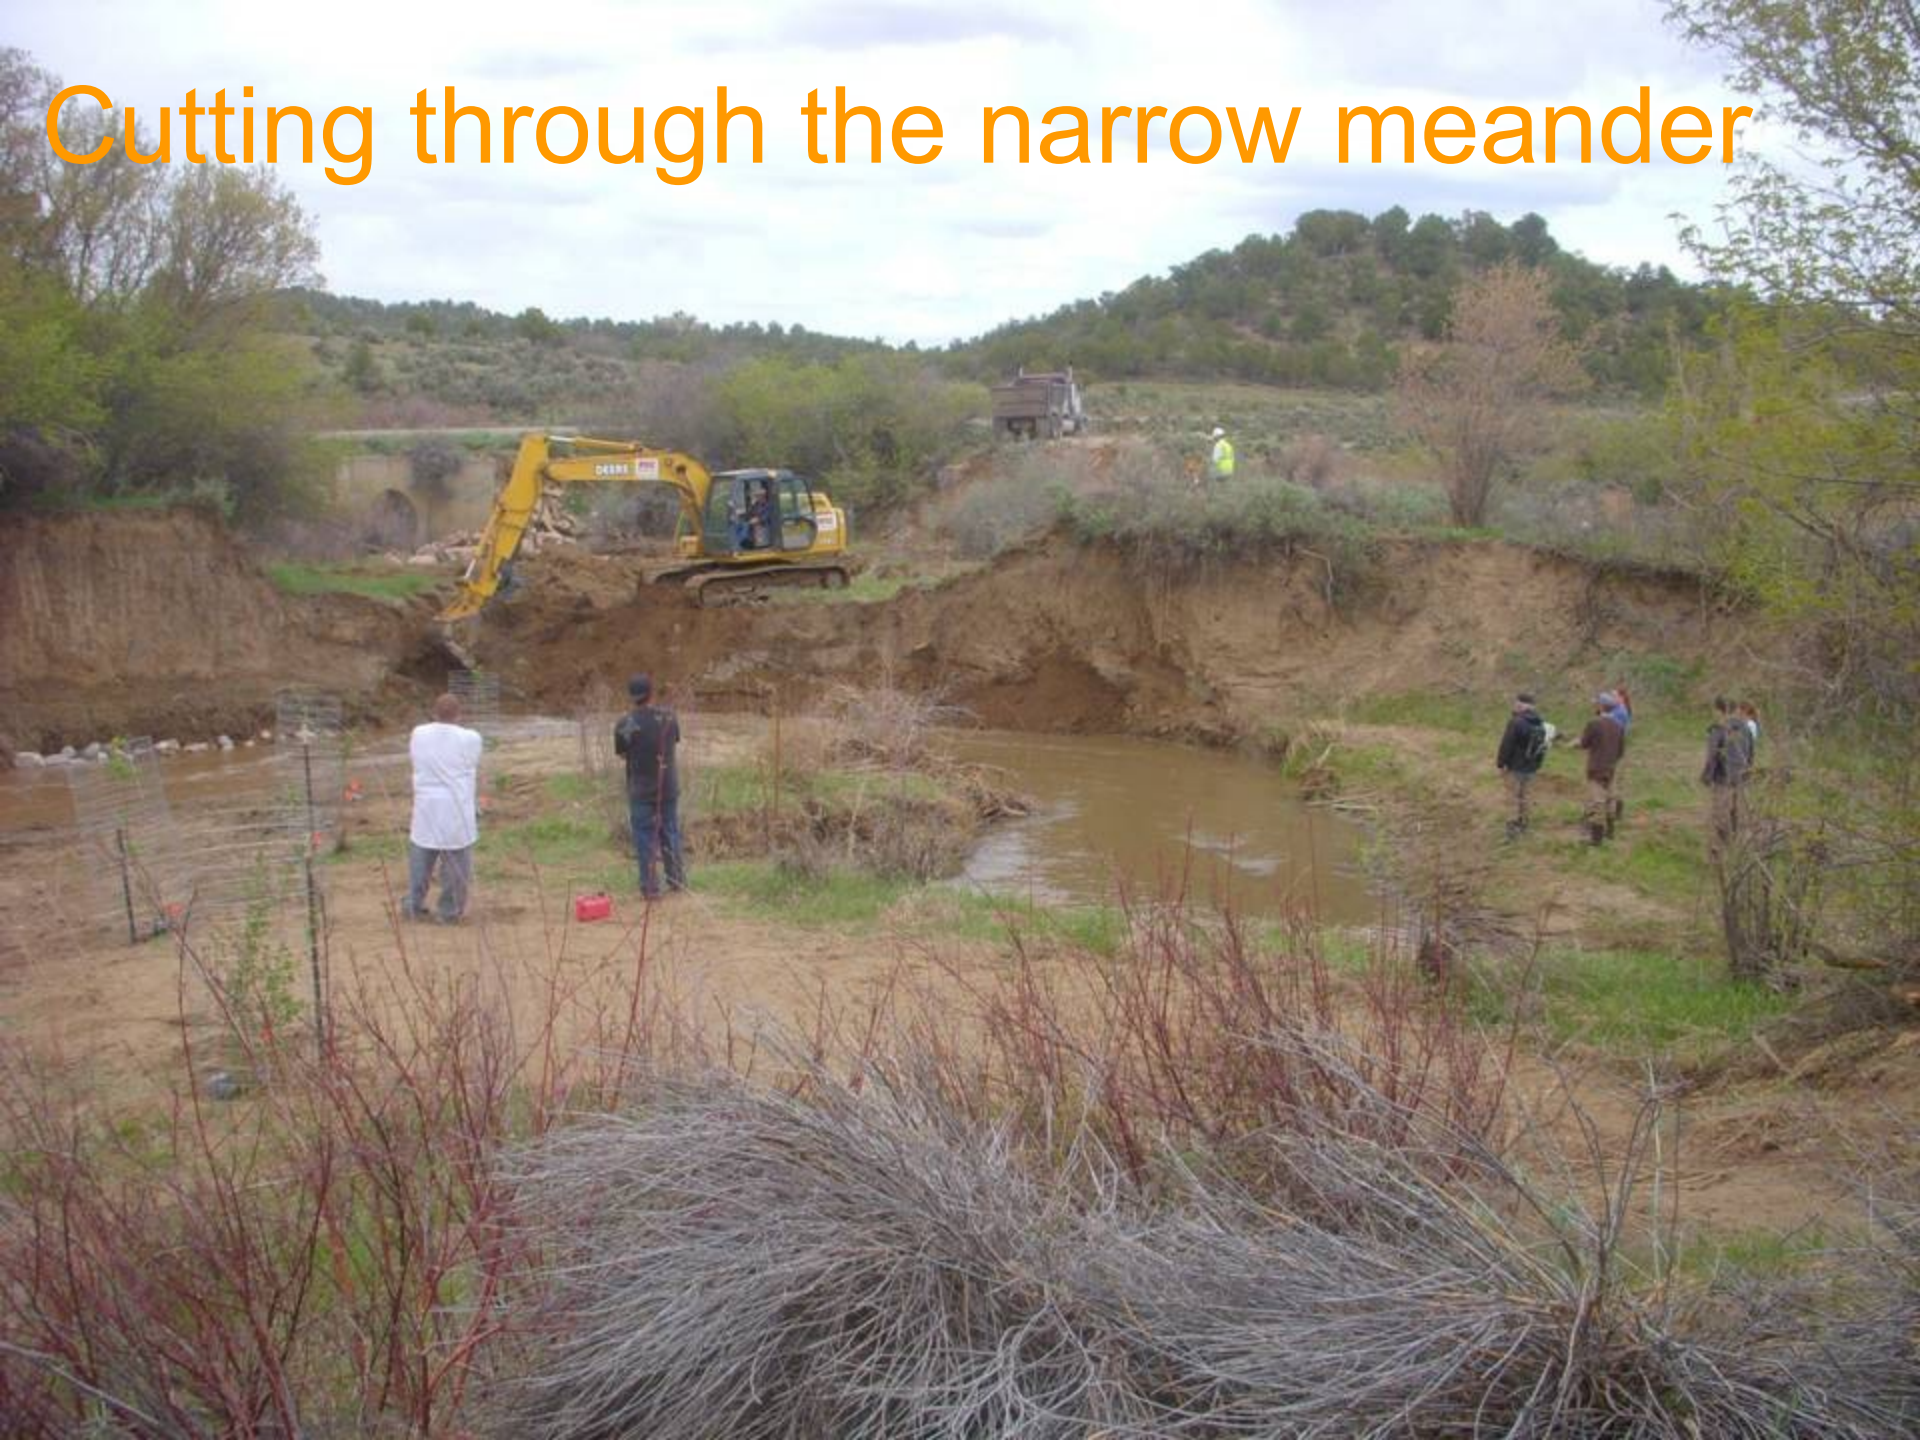
Eroding Flows

Cutting through the narrow meander

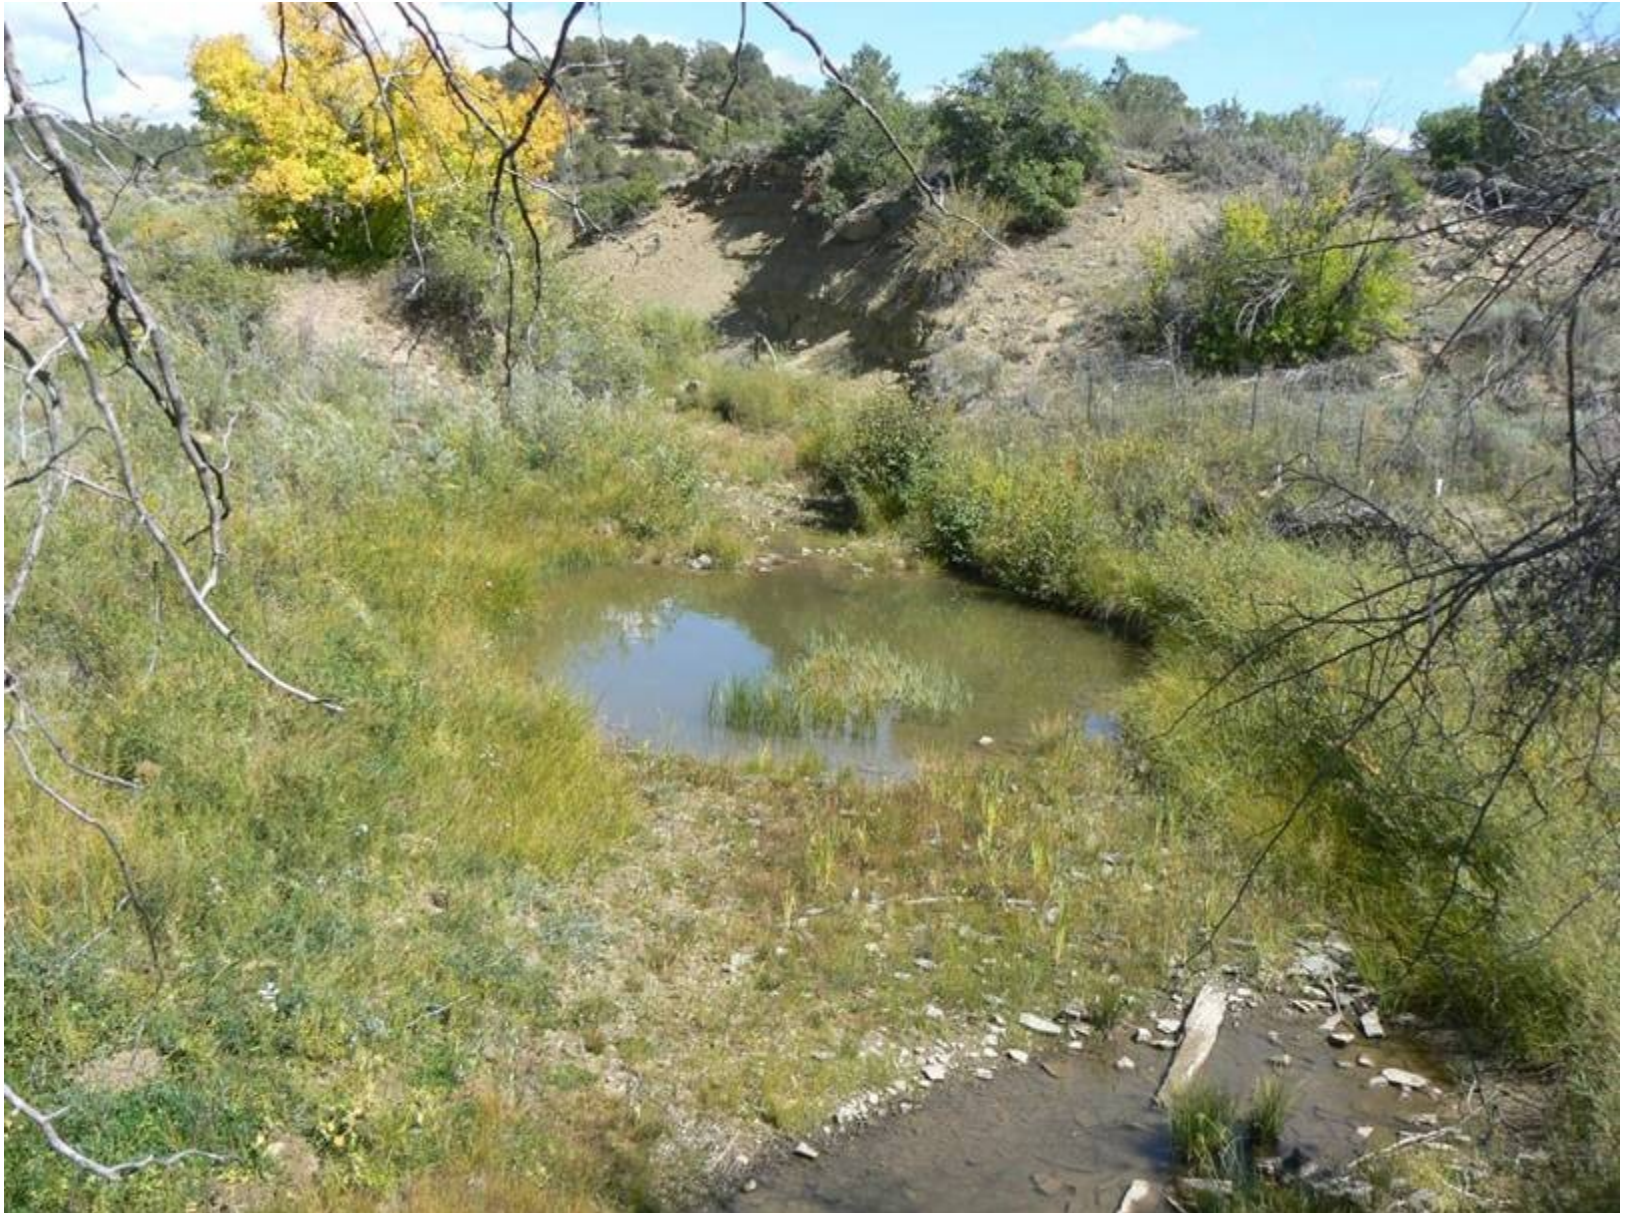
Step pools

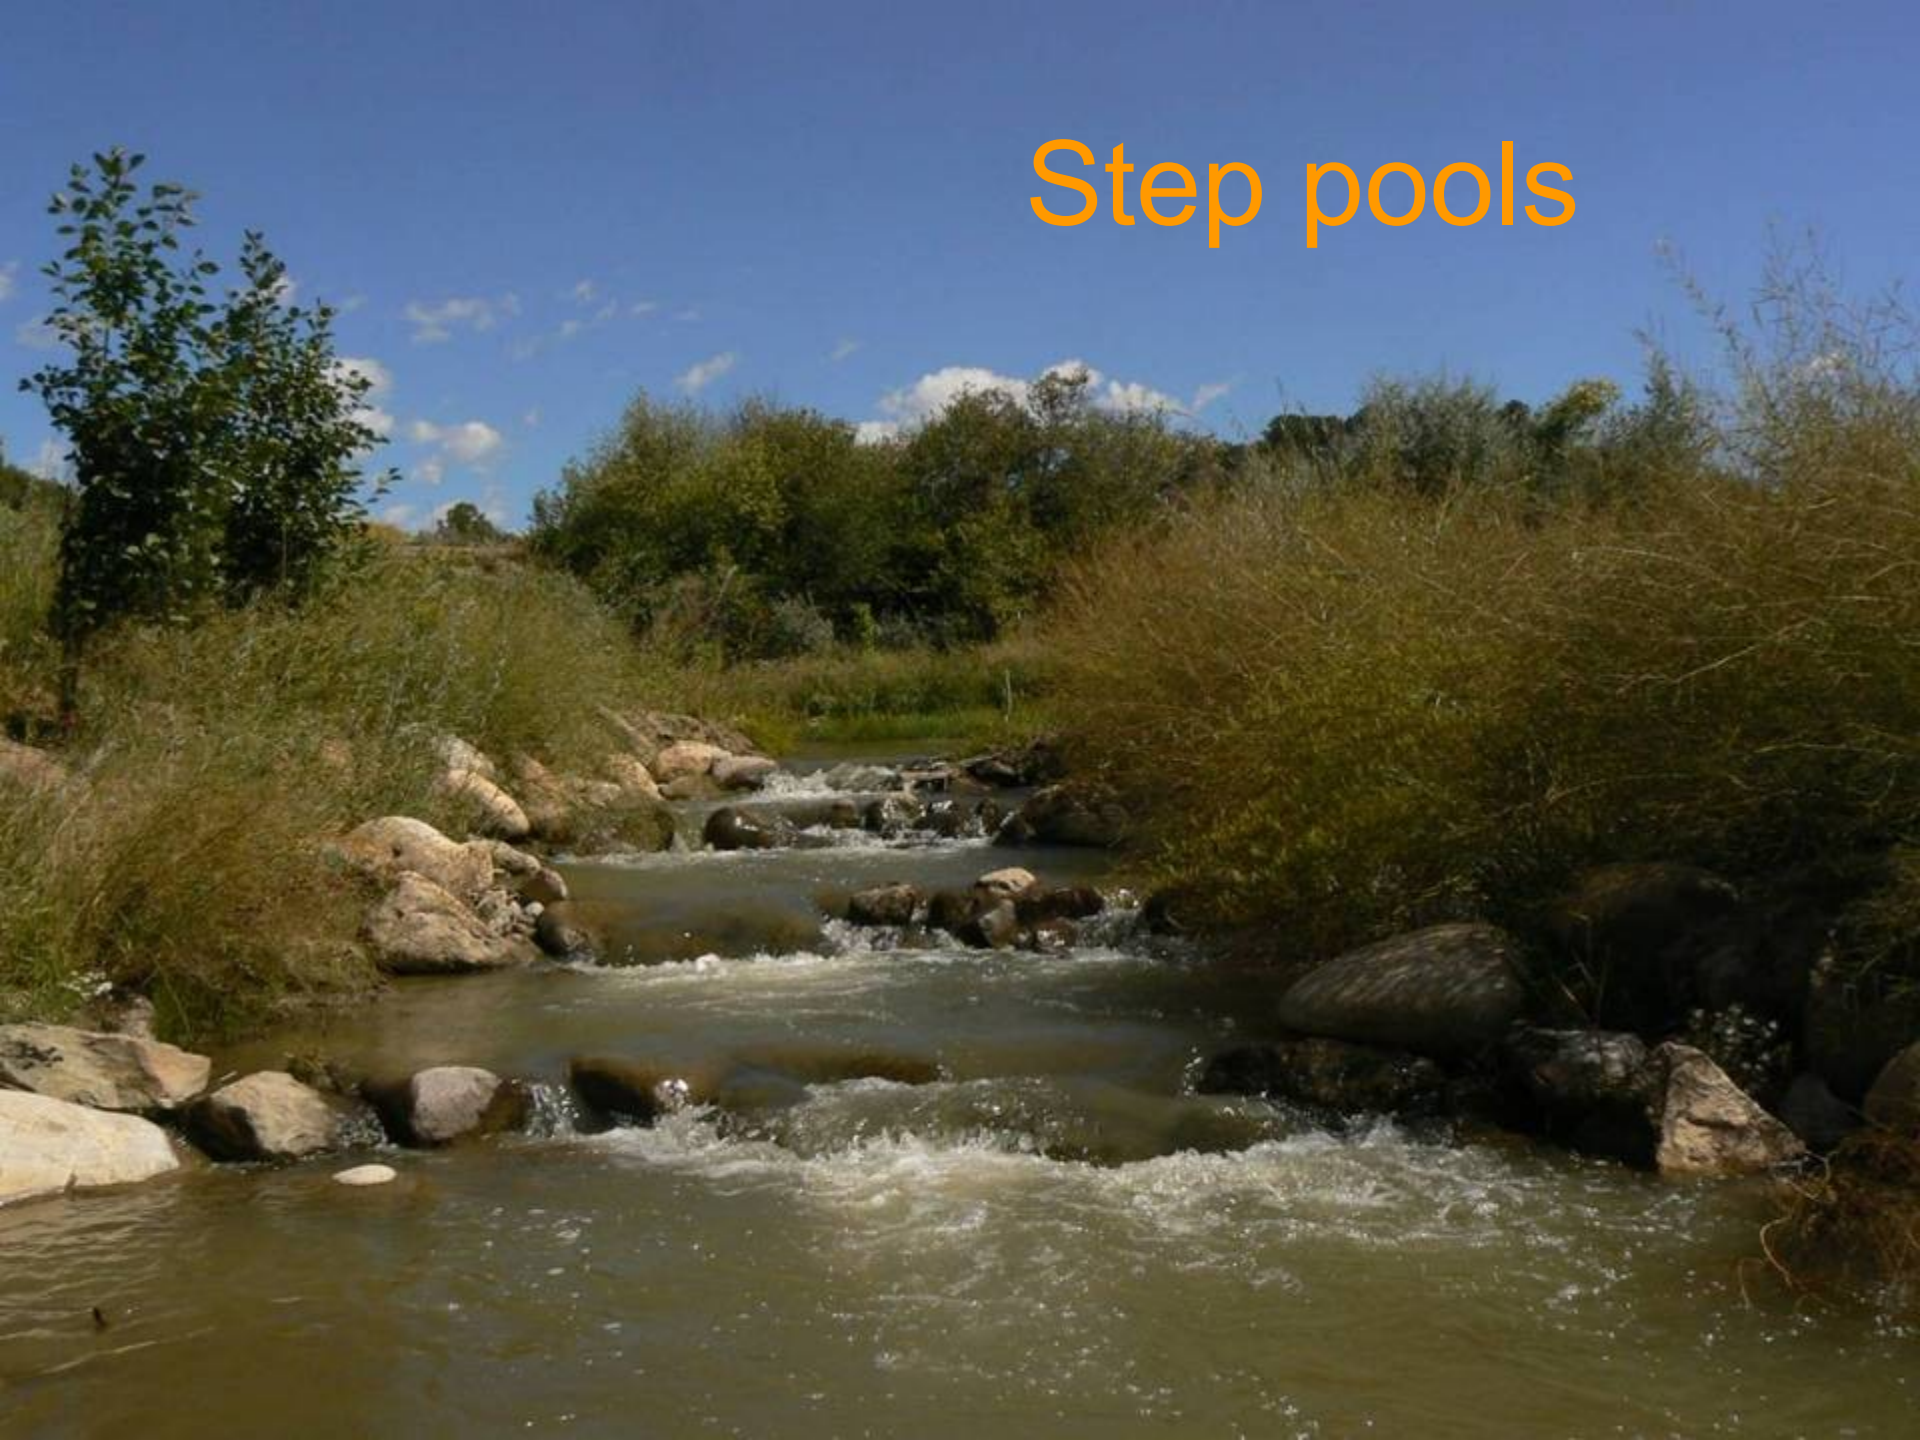
Creation of bankfull benches

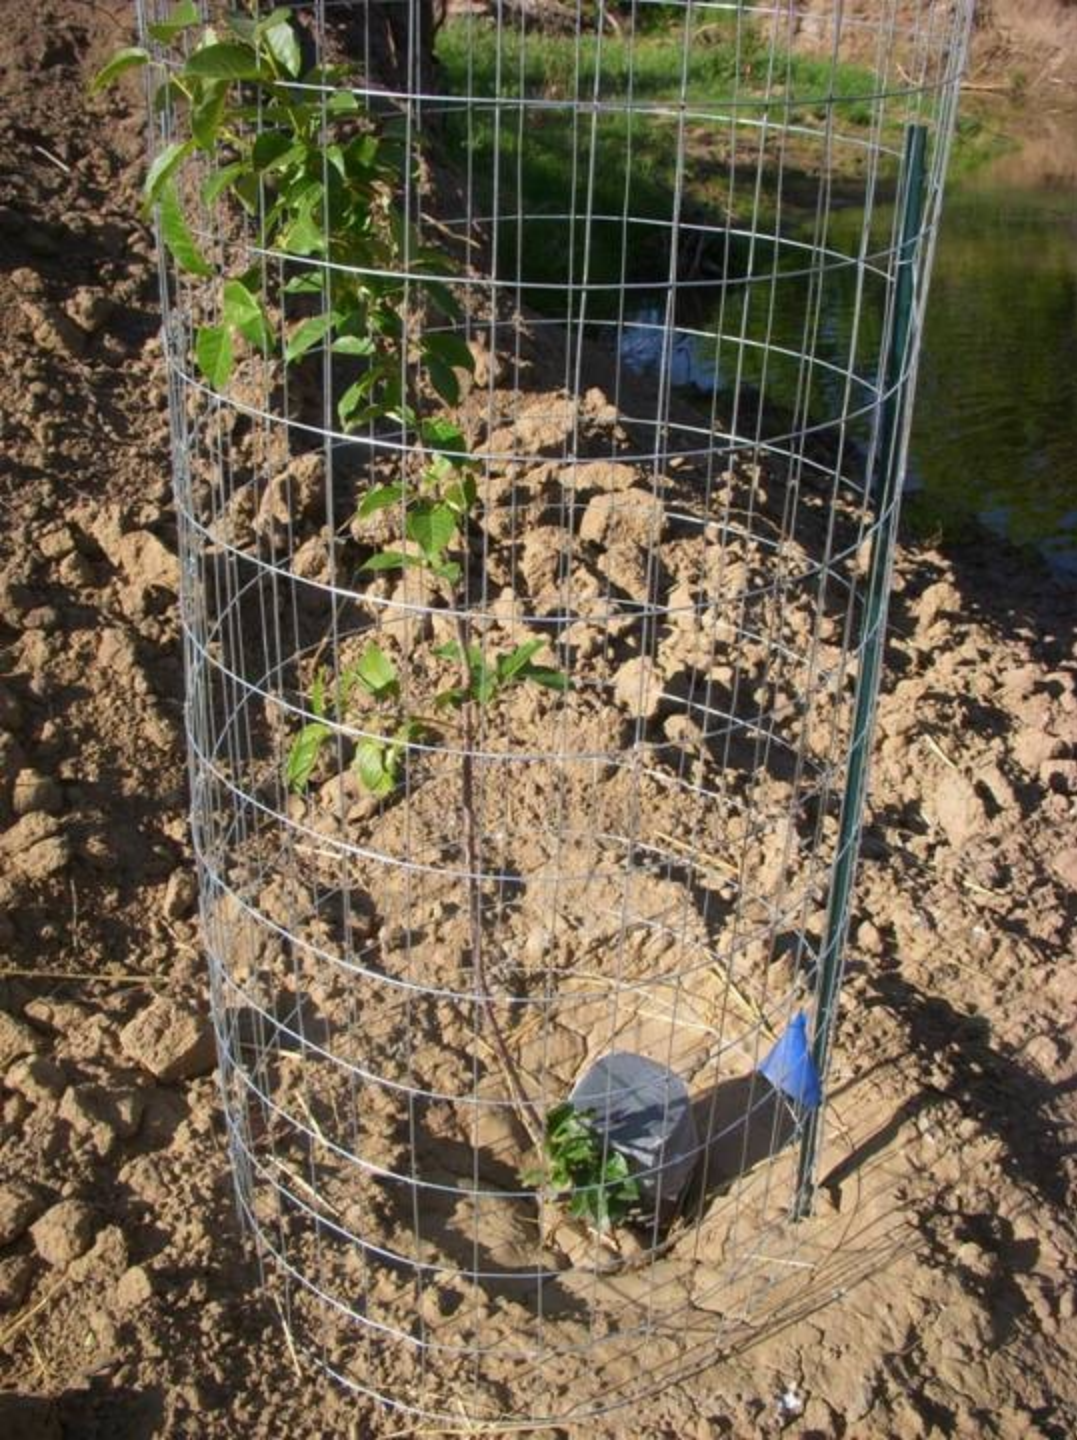
Watering tubes
