Workshop Example Application

- Eagle River (Edwards Reach) Case Study
 - Description
- DFMEA
 - Project Design → Compare RPNs
 - Implement Corrective Actions
 - Improve DFMEA
- Result → lowest risk design

- Eagle River Edwards Reach
 - Reach length 1.6 miles
 - Drainage area 600 square miles
 - Very flat 0.25 percent slope
 - Expansive floodplain along reach

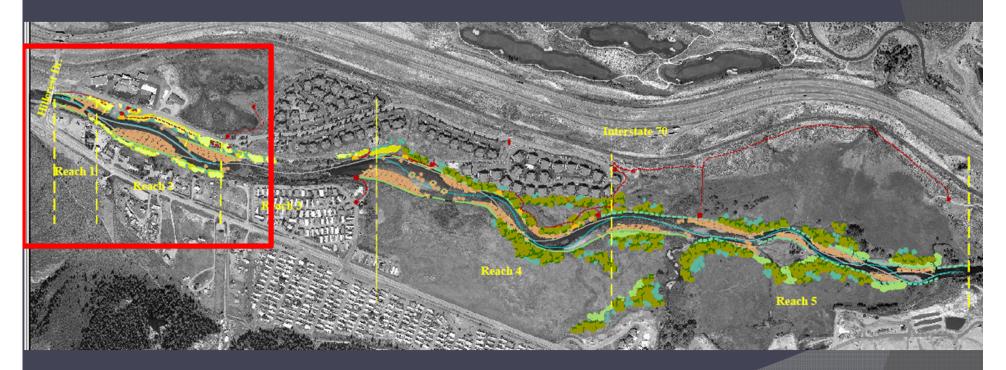
Five Reaches

- Focus on Reaches 1 and 2
 - Most urban and constricted

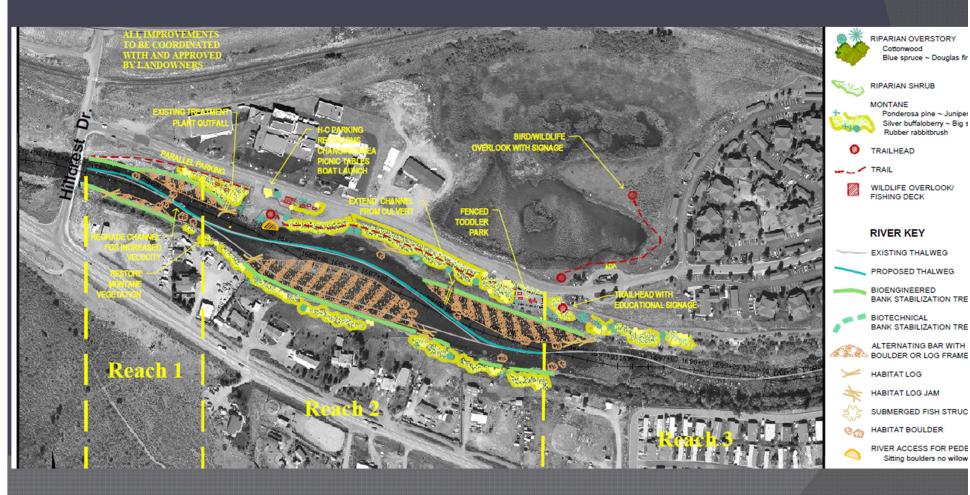
Reaches 1 and 2

- Channel Improvements
 - Cross Sectional Geometry Change modifications in width and depth
 - Regime Approach
 - HEC-RAS Hydraulic Modeling
 - Chang's/Parker's regime relationships for sand and gravel bed rivers
 - Longitudinal Slope Adjustment
 - Create positive gradient in Reach 1
 - increase velocities and decrease sediment deposition
 - Cross rock vane grade control structure

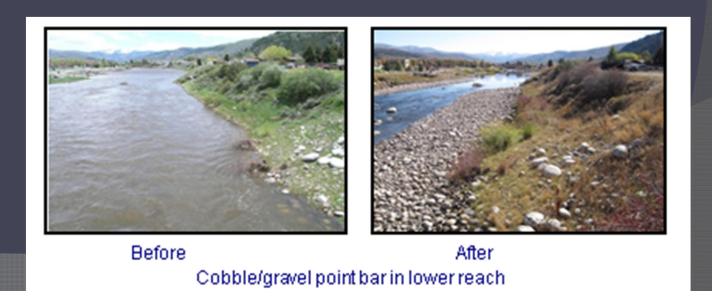
Channel Geometry - Cobble/Gravel Bars

- Alternating point bars natural and constructed restore low flow and bankfull regime widths, but still allow flooding
- Constructed out of boulder or log frames with smaller material on top to replicate substrate appropriate to system
- Project Goals surface water quality, sediment control, and improvement of health, function, and habitat

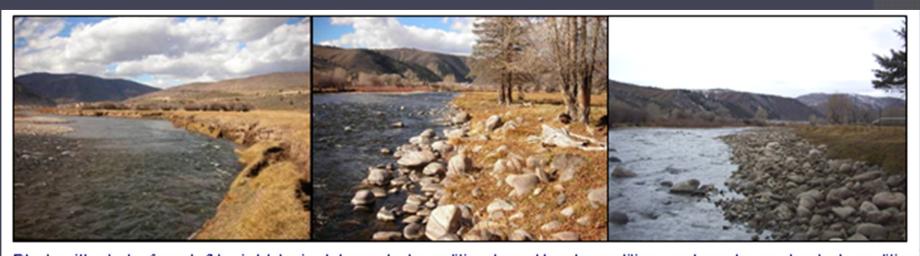
- Bank Stabilization
 - Bioengineered Treaments
 - Willow and Pole Treatments (in less severely eroded areas) – with boulder/cobble toe protection
 - Willow wattles and log toes, brush mattressing, brush revetments, soil reinforcement lifts

Photos illustrate, from left to right, typical degraded condition, target bank condition, and newly constructed condition

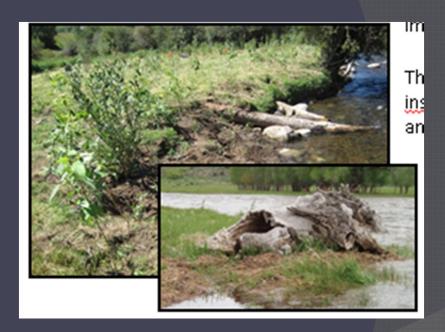
Aquatic Habitat Features

- Habitat boulders
- Habitat logs and log spurs
- Clusters and keyed into bank

stream health and function improvement, enhance aquatic habitat, reconnection of fisheries

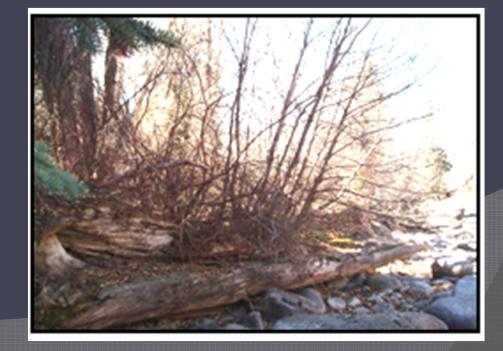
Native Plantings

Vegetation restoration with native plants

Ten different plants associations developed (willows, cottonwords and shrubs)
